WATER MANAGEMENT PLAN

**LOTS 4 AND 5 LUDLOW ROAD, MYALUP
SHIRE OF HARVEY**

B & J CATALANO PTY LTD

JULY 2018

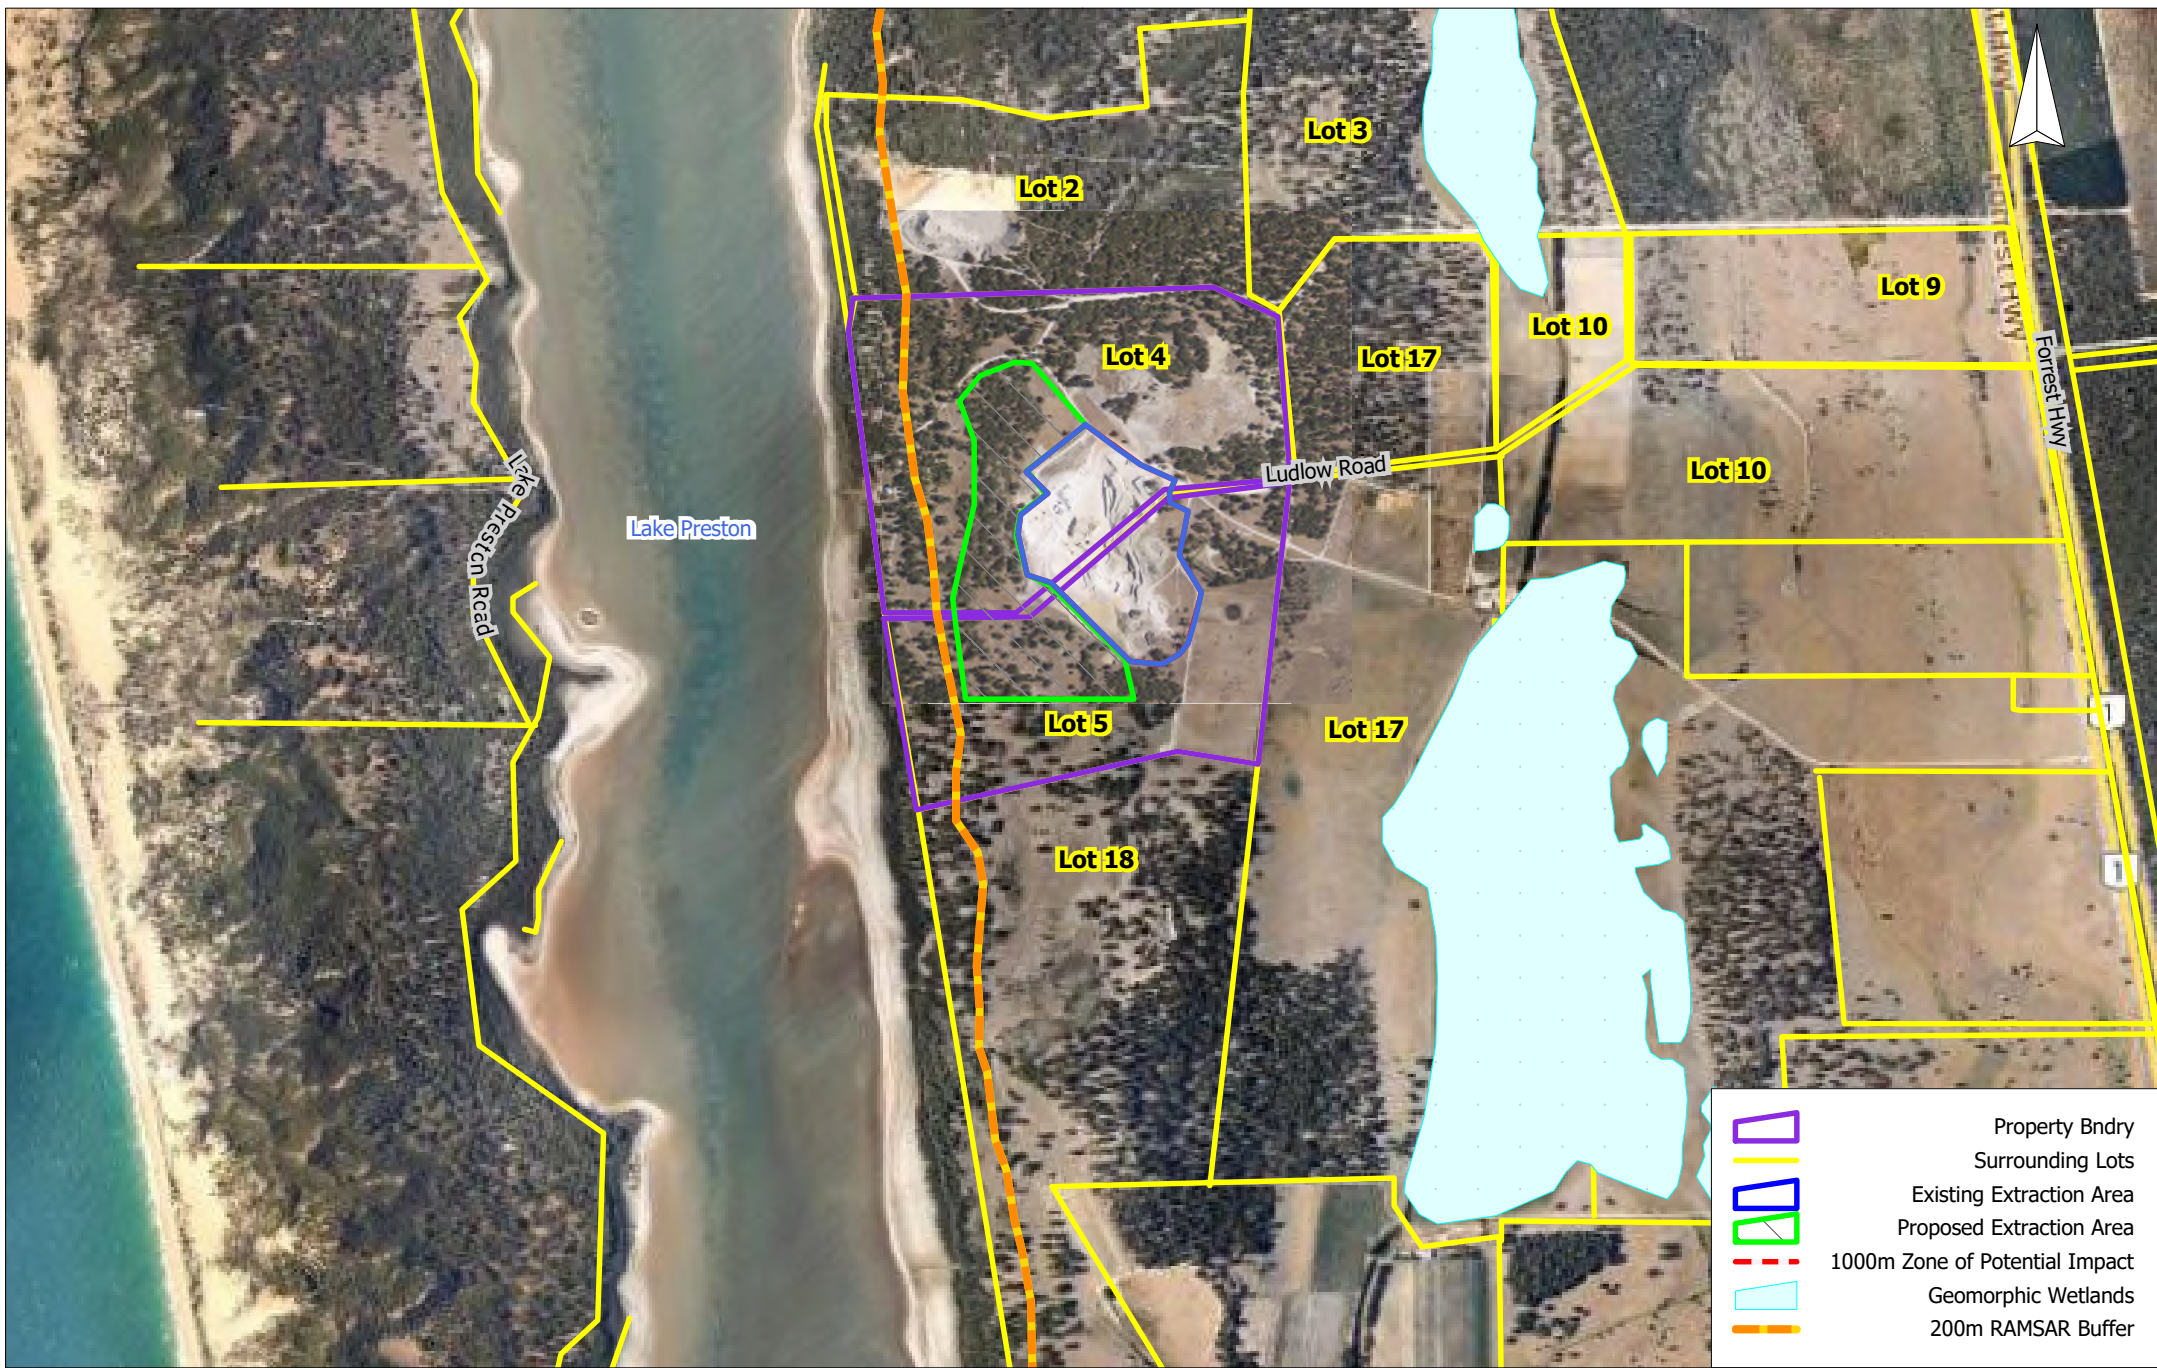
Property & Surrounds

The property is situated west of Forrest Highway, approximately 50km north of Bunbury. Lots 4 and 5 are bounded by Lake Preston to the west, Lot 2 to the north, Lot 17 to the east and Lot 18 to the south. Figure 1 shows the location of the proposed limestone extraction.

There are also a number of Multiple Use wetlands near the property (Figure 1). Three Dampland Multiple Use wetlands lie within 550 m of the properties (Landgate 2018).

Lake Preston runs along the western boundary of Lots 4 and 5 Ludlow Road (Figure 1). No surface drainage lines have been identified within the property, drainage is internal and infiltrates into the underlying groundwater.
