Annual Report CPS 5480/1, Lot 7 Runnymede Rd, Wellesley

B&J Catalano Pty Ltd
 Lot 7 Runnymede Rd
 Wellesley
 Sand Extraction

Clearing Permit Report
 1 Jan - 31 Dec 2016

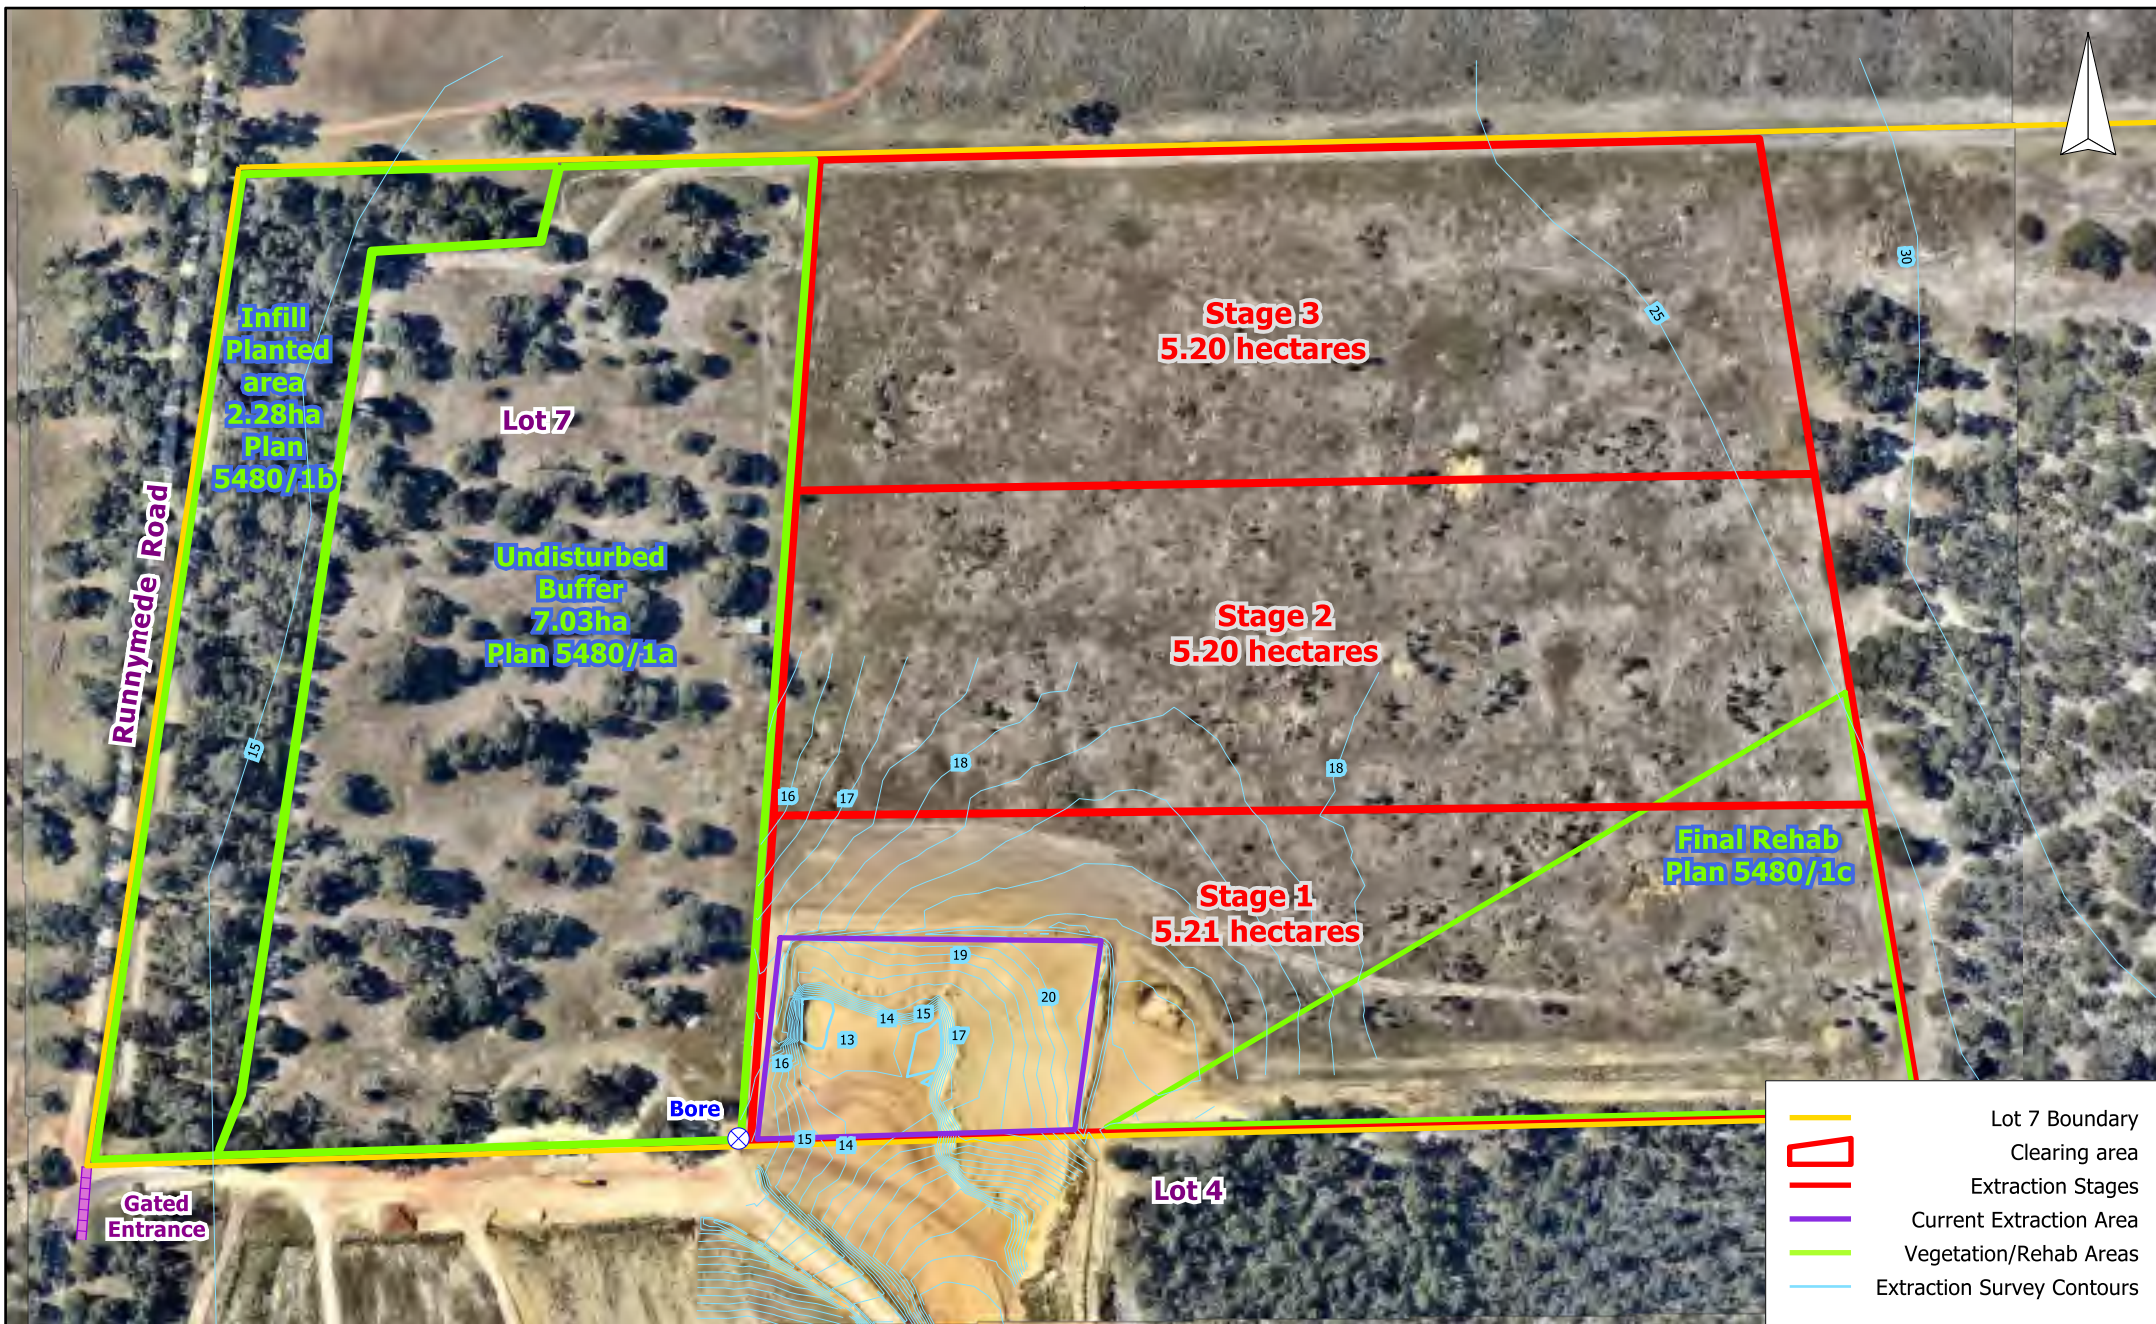
Figure 1

Scale: 1:2900
 Original Size: A4
 Air Photo Source: Nearmap Nov 2016
 Datum: Australian Geocentric 1994 (GDA94)

All clearing of native vegetation has been undertaken, however the landsurface is still covered in pasture grasses which will reduce the effects of wind erosion (as shown in Appendix 1 Plate 3). The area surrounding the active extraction area has been cleared of all vegetative material and topsoil has been scraped from the landsurface (Appendix 1, Plates 1 & 2 and Figure 1).

- (a) No clearing was undertaken during the 2016 reporting period.
- (b) Infill planting within the area outlined on Plan 5480/1b of the Clearing Permit (as illustrated in Figure 1) was undertaken during winter 2016. As discussed, additional infill planting is scheduled for subsequent winters.

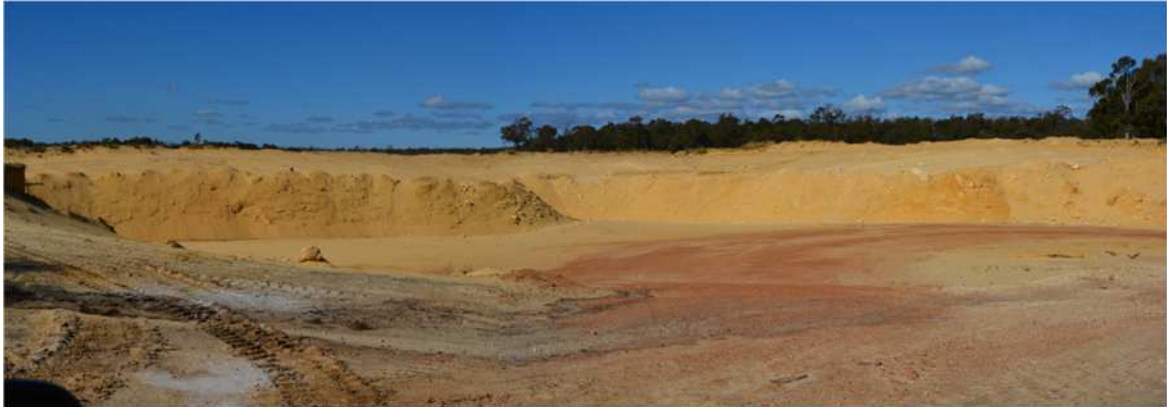
Plate 1 - Panorama of Lot 7 extraction area, top soil scraped from immediate surrounds of active extraction area, vertical depth of extraction approximately 4 metres.

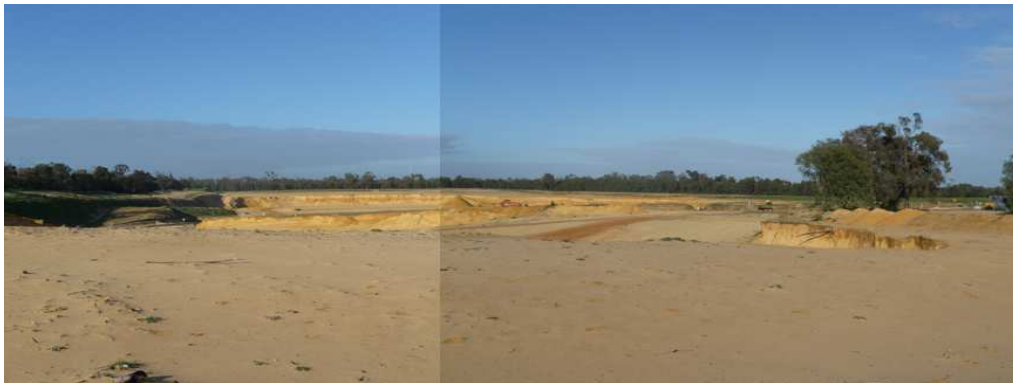
Plate 2 - Top of active extraction area (Lot 4 Runnymede extraction activities in central background) showing scraped top soil stockpiles to the right.

The Permit Holder has retained the vegetative material and topsoil in cleared areas (Appendix 1, Plate 2). As extraction is not yet complete rehabilitation and revegetation activities within the Permit area have not commenced.

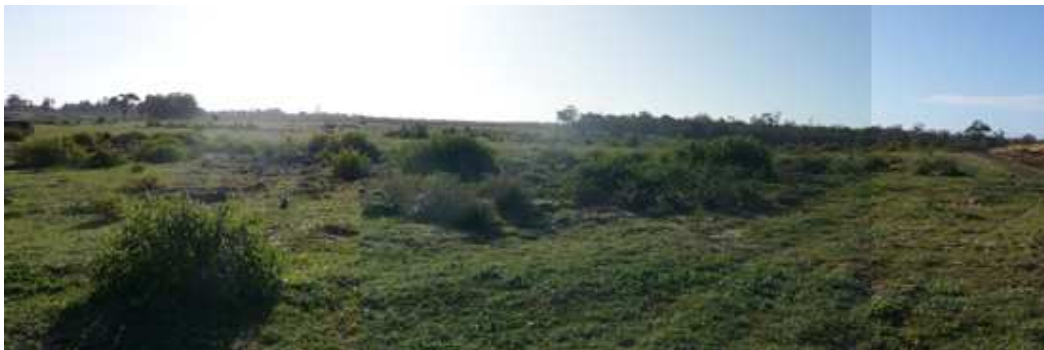
Plate 3
Cleared area of Lot 7 showing strong growth of pasture grasses and some native vegetation regrowth.

All clearing has been undertaken, however there has been some regrowth of native vegetation that will be required to be cleared as extraction progresses (see Appendix 1, Plate 3). This will be finalised prior to 12 April 2018 as allowed under this clearing permit.

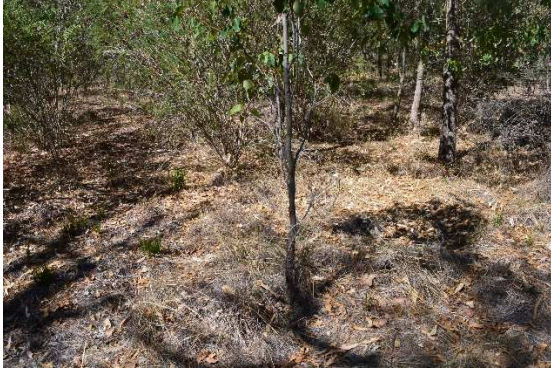
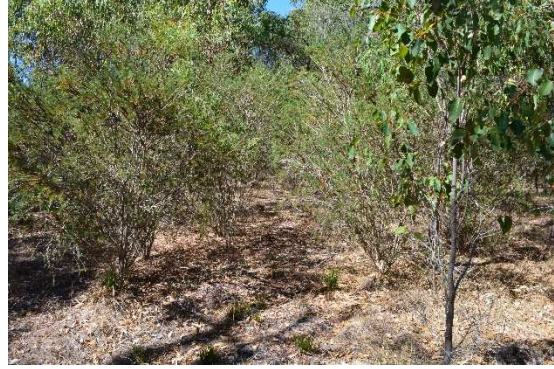
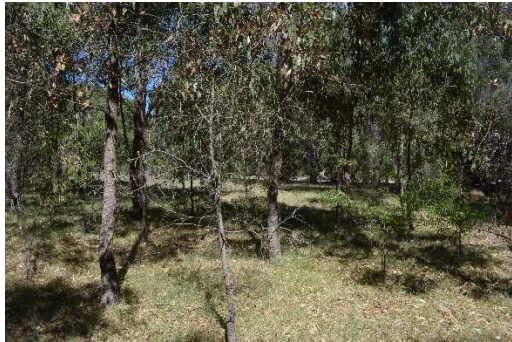
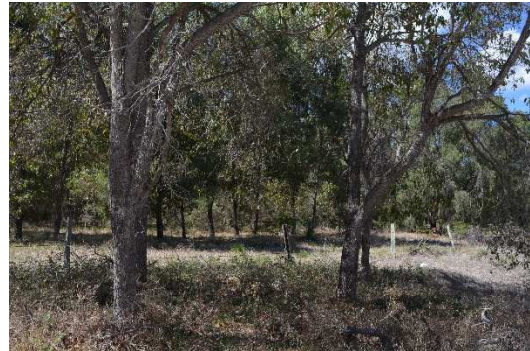
Showing vegetation density of area requiring infill planting on Plan 5480/1b of Clearing Permit. Infill planting subsequently undertaken in winter 2016.

A survey undertaken by Lundstrom Environmental Consultants in March 2016 of the Plan 5480/1b infill area, found a total live stem count of 1132 plants over the 2.28ha, equating to approximately 500 live stems per hectare. Infill planting occurred in this area in winter 2016 and additional infill planting will occur during winter 2017, with further planting planned in following winters until an average of 1100 live stems per hectare is achieved.
